Epoxy Used for Rehabilitation of Large-Diameter Pipes

Published in Municipal Sewer & Water

January 2022

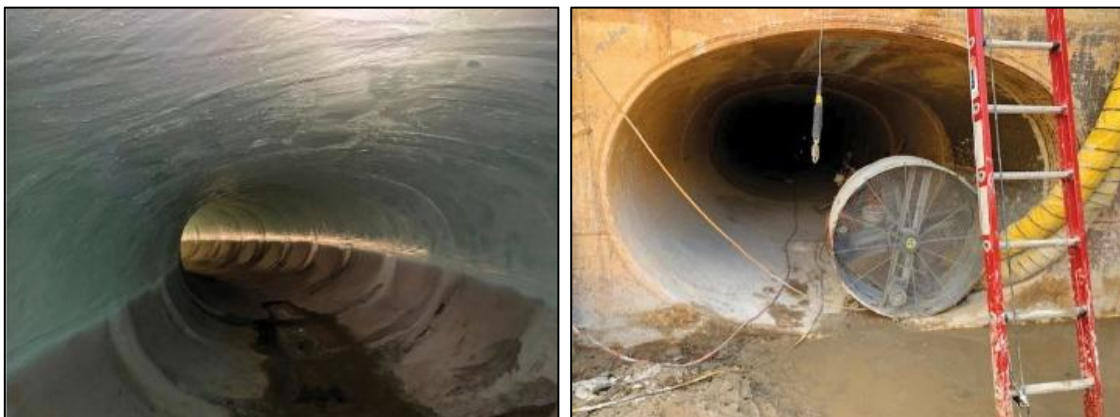
Problem: A 370-foot-long 87- by 136-inch elliptical pipe and 541-foot-long 96-inch-diameter pipe both had severe crown corrosion at San Jose Water Treatment Plant. An assessment estimated the remaining service life range of the pipes between 0 and 12 years. A high priority was given to performing a structural lining on these pipes.

Solution: Michels Pipeline recommended using geopolymer for repairing badly deteriorated spots, followed by coating the pipes with Neopoxy high-strength corrosion-resistant NPR-5304 epoxy resin. The project owner decided to line only the top half of the pipes due to the more serious corrosion in that area. The Michels crew applied epoxy using plural component spray equipment at 125 to 150 mil thickness.

Result: The project was completed successfully. The coating successfully passed the spark and adhesion tests, and the pipes were back in service within a few days. Through the application of the epoxy, the lifespan of the large-diameter pipes was extended by approximately 50 years. 510-782-1290; www.neopoxy.com
