**Epoxy Used to Rehab Corroded Large-Diameter Pipe in San José**  
*Published in Municipal Sewer & Water*  
*January 2024*

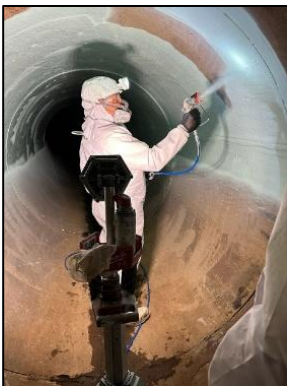
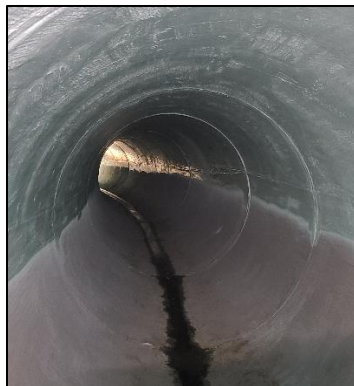
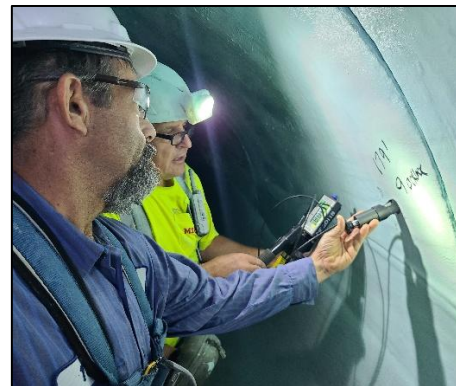
**Problem:** The San José-Santa Clara Regional Wastewater Facility had 900 feet of 84-inch-diameter pipe with severe crown corrosion. Several areas had extensive concrete spalling with exposed rebar. An assessment estimated the remaining service life of the pipe between 0 and 12 years. A high priority was given to coating the pipe to lengthen its lifespan.

**Solution:** Michels Pipeline patched badly deteriorated spots with cementitious material, followed by coating the pipe with Neopoxy high-strength corrosion-resistant NPR-5303 epoxy resin. The project owner decided to line only the top 200 degrees of the pipe due to the more serious corrosion in that area. The Michels crew applied epoxy at a thickness of 150-250 mils using plural component spray equipment.

**Result:** The project was completed successfully. The coating successfully passed spark and pull testing. Several of the pull test results were over 1,500 psi (project specs required 250 psi minimum), with a clean concrete break rather than a separation of the coating and substrate. The pipes were back in service within a few days. Through the application of the Neopoxy NPR-5303, the lifespan of the large-diameter pipe was extended by approximately 50 years. 510-782-1290; [www.neopoxy.com](http://www.neopoxy.com)
