Epoxy Resin Used to Rehab Large Corroded Pipes at WWTP
Published in Municipal Sewer & Water
January 2025

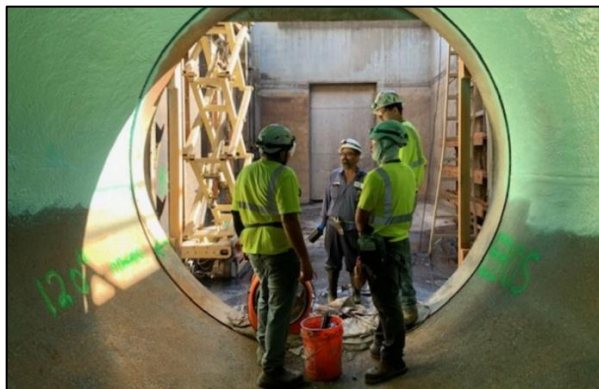
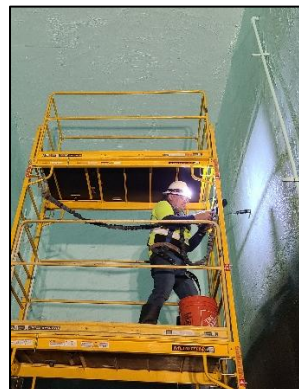
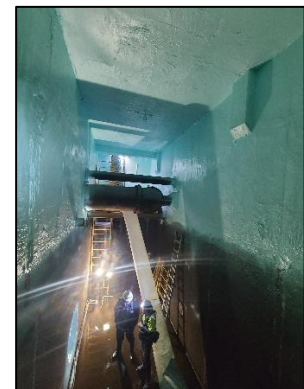
Problem: The San José-Santa Clara Regional Wastewater Facility had 1,800+ feet of massive 120- and 102-inch-diameter pipes with severe crown corrosion. Several areas had extensive concrete spalling with exposed rebar. An assessment estimated the remaining service life of the pipe between 0 and 12 years. A high priority was given to coating the pipes to lengthen their lifespan.

Solution: As part of the WTP Yard Piping Improvements Phase 2 project, Michels Pipeline patched badly deteriorated spots with cementitious geopolymer material, followed by coating the pipes with Neopoxy high-strength corrosion-resistant NPR-5303 Epoxy Resin. The project owner decided to line only the top 200 degrees of the pipe due to the more serious corrosion in that area. The Michels crew applied epoxy at a thickness of 150-250 mils using plural component spray equipment.

Result: The project was completed successfully. The coating successfully passed spark and pull testing. Several of the pull test results were over 1,500 psi (project specs required 250 psi minimum), with a clean concrete break rather than a separation of the coating and substrate. The pipes were back in service within a few days. Through the application of the Neopoxy NPR-5303, the lifespan of the large-diameter pipe was extended by approximately 50 years. 510-782-1290; www.neopoxy.com
